SALT CREEK AND TRIBUTARIES, NEBRASKA
SITE NO. 13
TWIN LAKES DAM AND RESERVOIR

EMBANKMENT CRITERIA AND PERFORMANCE REPORT

Prepared By: United States Army
Corps of Engineers
Omaha District

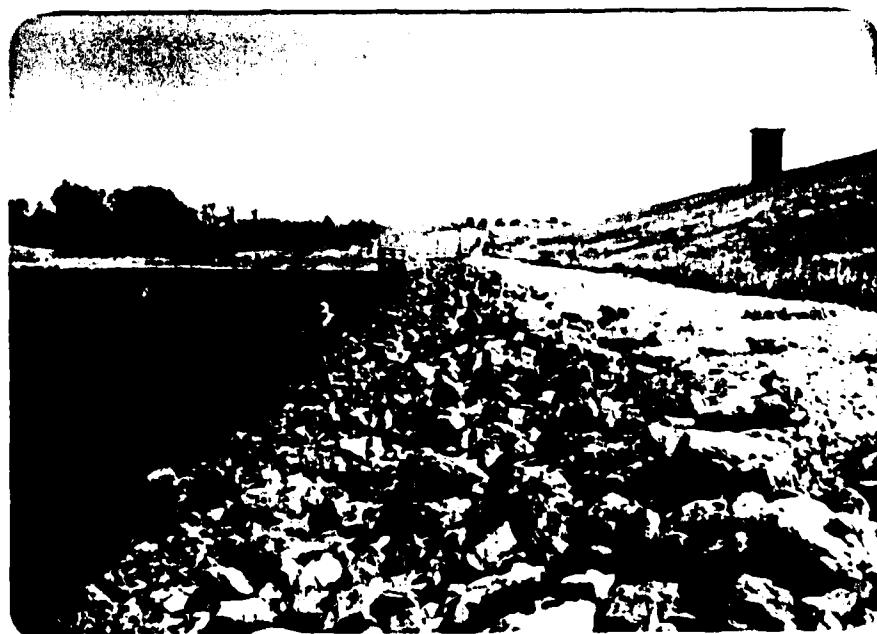
10.4.1 Riprap. During an inspection in 1969 and all annual inspections up to and including the first periodic inspection in 1974; it was noticed that the limestone riprap slope protection was gradually deteriorating, and that several areas had settled enough so that the top of the stone was below the design top elevation. The periodic inspection report recommended that the riprap be repaired and that an access road be constructed on

Photo No. 5 - Riprap with access berm on east embankment. Intake structu. in background and water stage recorder housing at upper right. (Oct. 1979)

the face of the dam above the riprap for routine repair or replacement of the riprap. Subsequently, in 1975, the Area Office of the Omaha District placed additional limestone riprap on the existing stone and constructed a small access road at the top of the riprap. Crushed limestone rock was also placed on the crests of both embankments. The riprap and crushed rock were obtained from Hopper Brothers quarry near Ashland, Nebraska. Photos 2 through 7 show various views of the riprap, access road berm and gravel crests.

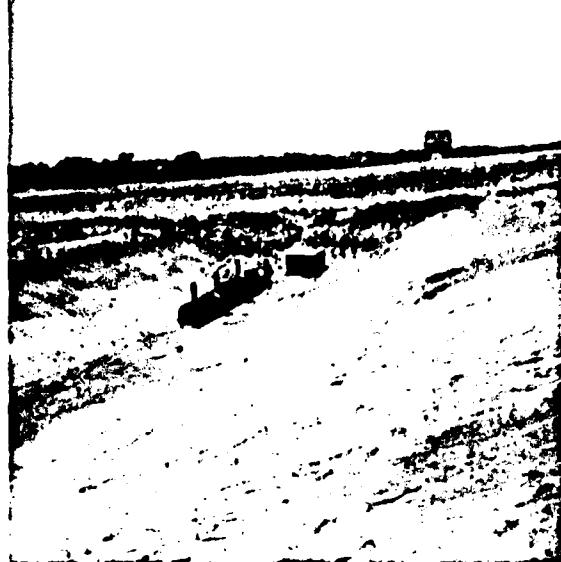
Photo No. 10 - View of discharge conduit and discharge channel during construction. Intake structure is in background. (June 1965)

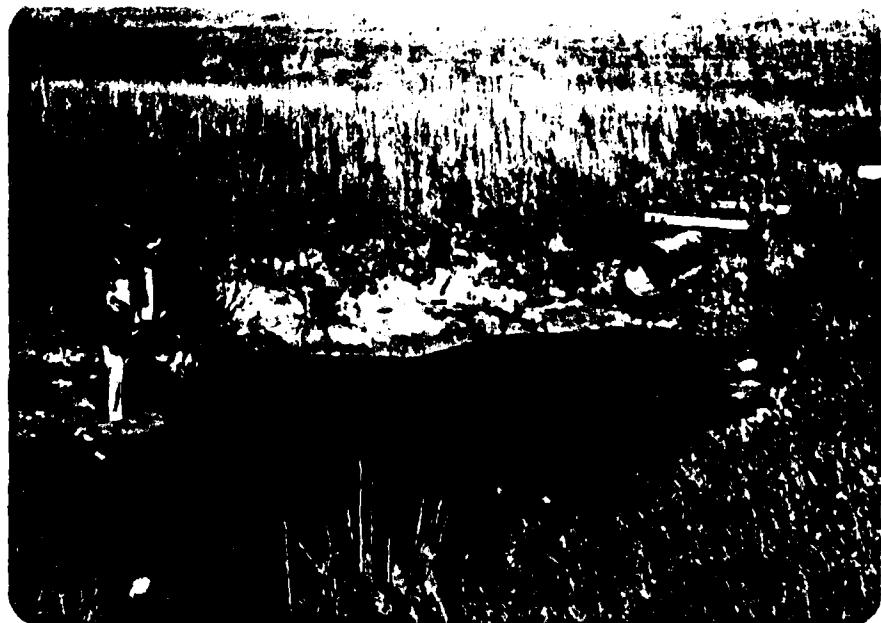
Subsequently, in September 1977, a contract was awarded to Technical Inspection Corp of Lincoln, Nebraska (Contract No. 77-C-0101) to grout the voids in the backfill around the conduit, and to reshape the cut slopes of the plunge pool which had been damaged due to erosion.

Photo No. II - View of outlet end of discharge conduit and plunge pool of east dam. Note erosion along right side of plunge pool. (Oct. 1979)

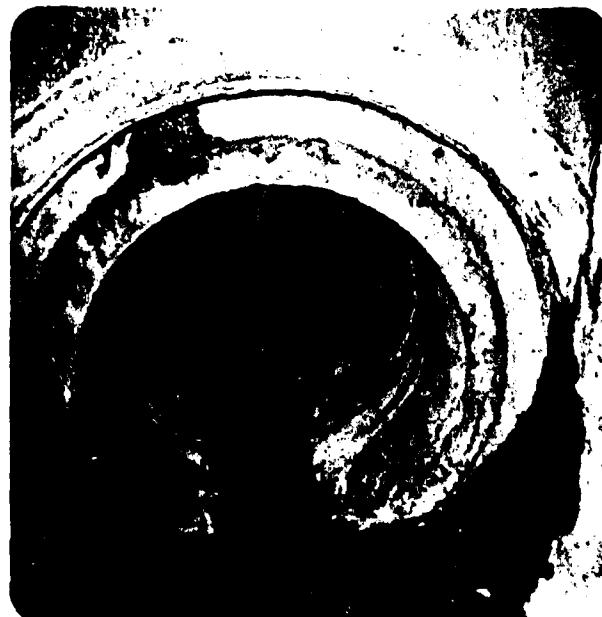
Photo No. 13 - View of a typical discharge conduit after concrete lining had been installed.

Additional rehabilitative measures were accomplished on the outlet conduit in 1980. Because of a general deterioration of the bituminous lining and corrosion holes which completely penetrated the corrugated metal conduit at this project and also at Sites 2, 9 and 10, it was decided to install a 30-inch diameter 3-1/2-inch thick precast reinforced concrete pipe lining inside of the 42-inch diameter corrugated metal pipes. A contract for this work was awarded on 9 May 1980 to Dobson Brothers Construction Company of Lincoln, Nebraska, under contract number 80-B-0151. The final contract amount for the four sites was \$238,699. The work consisted essentially of furnishing and installing the concrete pipe liners, grouting the annular space between the pipes, and installing air vents for the pipes. The precast pipe lining was specified to conform to ASTM C76, Class V wall, B pipe. Steel ring joints with round rubber gaskets were required.
